FLUID FILM BEARING FUNDAMENTALS AND FAILURE ANALYSIS

Fouad Y. Zeidan

Bernard S. Herbage

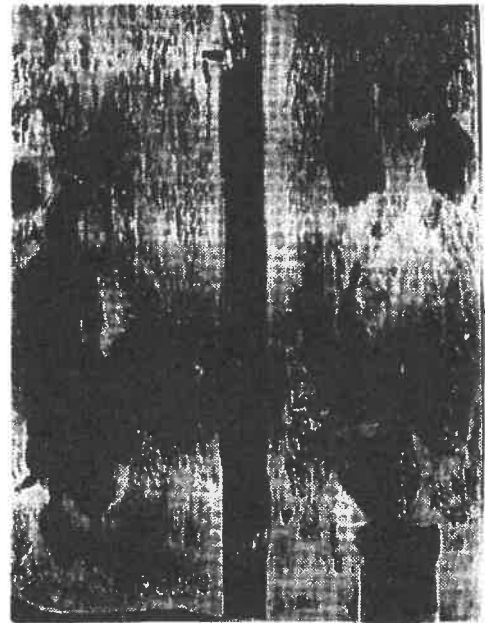
Loose fit. Inadequate interference fit on thin shell bearings causes excessive flexing and fretting damage to the O.D. of the shell and to the housing bore. The severe fretting due to insufficient contact pressure is shown in Figure 33 where local welding and tearing can be seen to have taken place between the thin bearing liner and the housing. Fretting on the housing bore is shown in Figure 34. These fretting protrusions must be completely removed before a new bearing liner is installed to prevent the possibility of seizure. Warriner [10] shows fretting damage at the bearing shell joint faces. This is shown in Figure 35 and is caused by the bolts slackening off during service. Insufficient crush, on the other hand, can result in the appearance of a highly polished area on the back of the bearing shell as shown in Figure 36. Other possible causes for the insufficient crush could be due to filing of

Figure 33. Severe Fretting of Bearing Shell O.D.

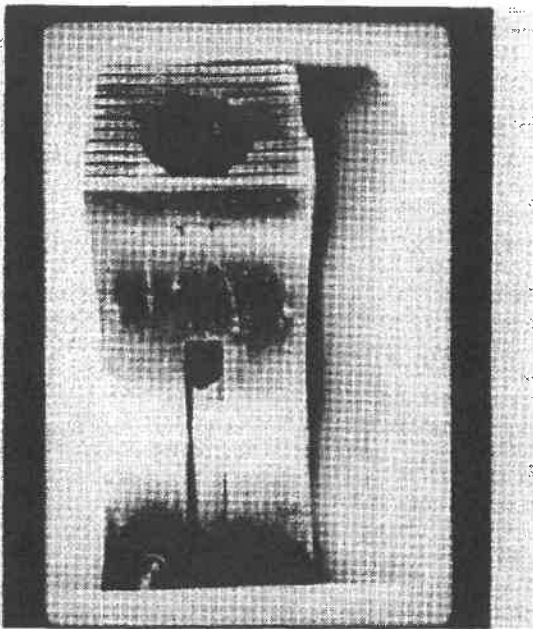
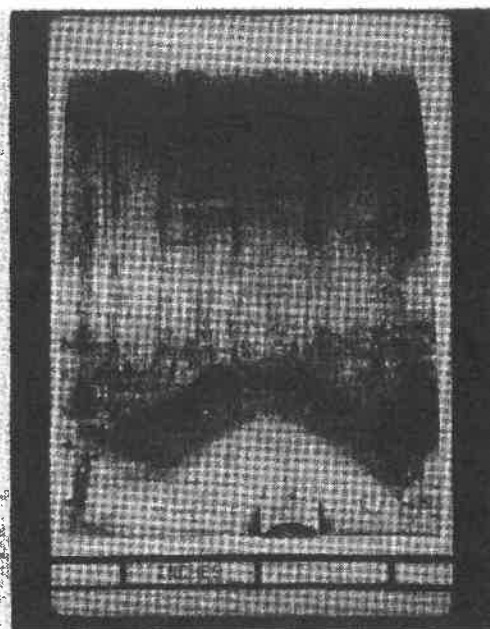
*Figure 34. Fretting on Bearing Housing Bore.*

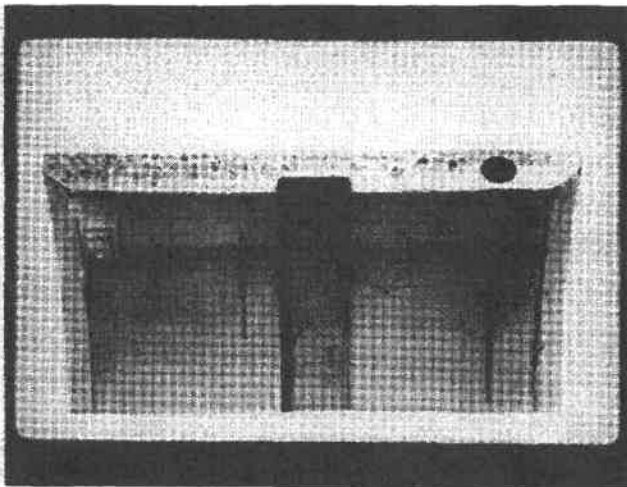
*Figure 36. Polished Surface Due to Loose Fit.*

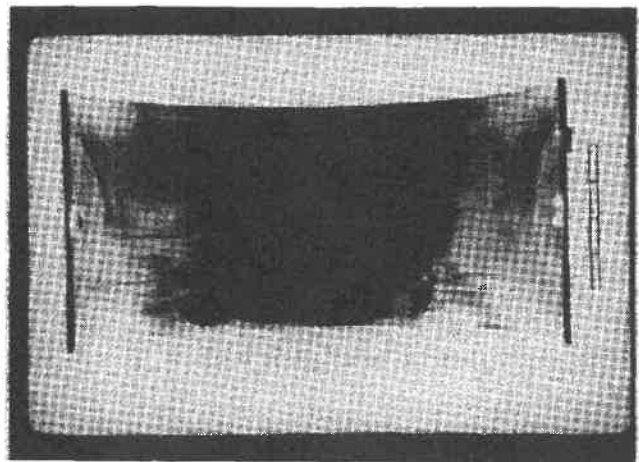
The amount of misalignment a sleeve bearing can take, depends to a large extent on the loading and, subsequently, the minimum film thickness, in addition to the bearing length. The misalignment a sleeve bearing can accept is generally very small. Misalignment can cause edge loading and excessive wear of the bearing surface. This problem is recognized by a distorted wear pattern as shown in Figure 38.

Figure 38. Uneven Wear Pattern Due to Misalignment.

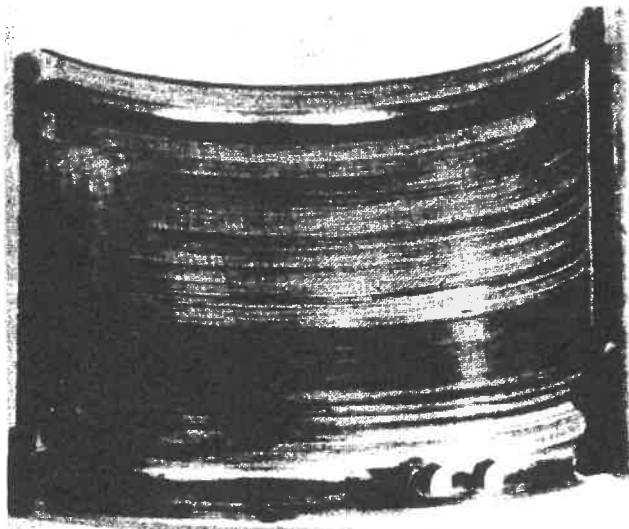
These failures are sudden and seem to be associated with an initiating mechanism, which then develops into a typical self propagating machining type process, whereby the shaft is machined away rapidly by an extremely hard scab embedded in the babbitt. The scab builds up from accumulated shaft turnings, which consist mainly of iron carbide. The most prevalent initiating mechanisms are foreign metallic particles. These break through the oil film and establish running contact. The bearing is shown in Figure 45 with deep melted cavities with scab embedded. The mating shaft had deep grooves after a relatively short running time.

Figure 45. Hard Black Scab in a Babbitted Journal Bearing and the Mating 3 percent Cr. 1/2 Percent Mo. Steel Shaft.

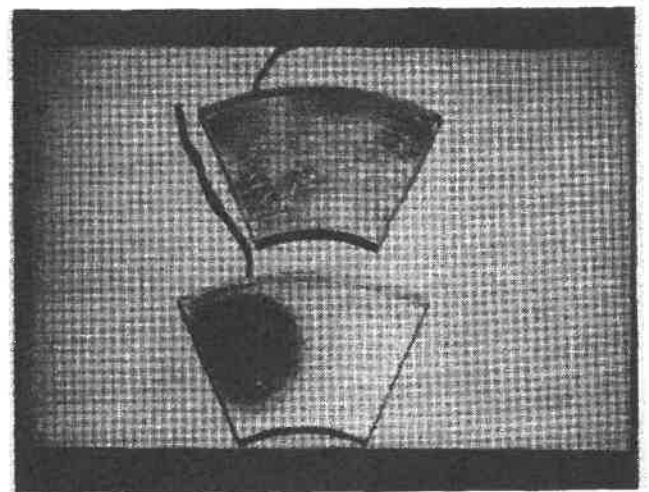
Figure 46. Thermal Ratchetting and Babbitt Creep on a Thrust Pad.

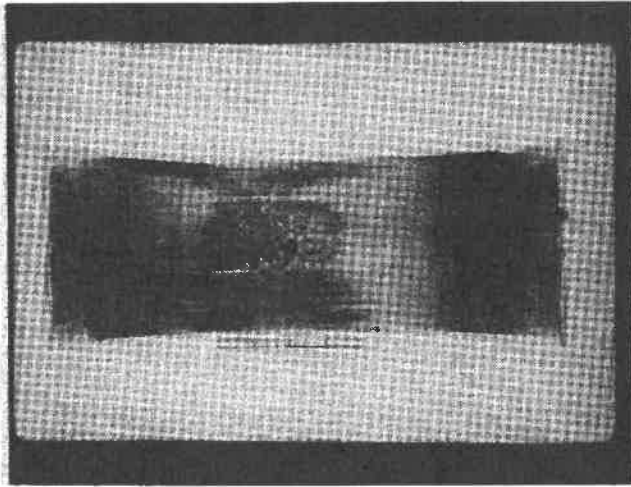
Figure 47. Pits and Cracks on Bearing Surface Caused by Corrosion.

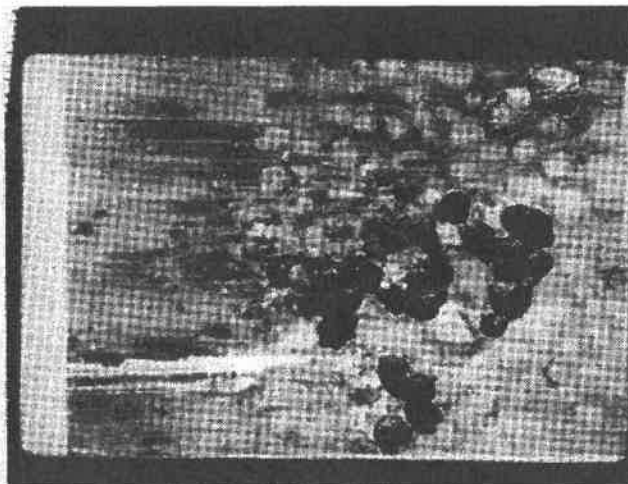
Figure 48. Closeup View of the Corrosion Attack Shown in Figure 46.

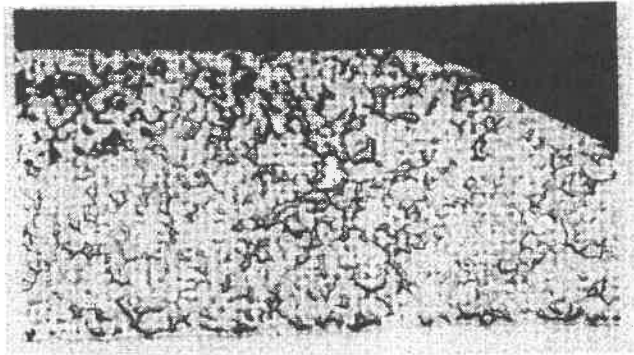
Figure 49. Microsection Showing Corrosion of the Sinter Copper Lead Structure.

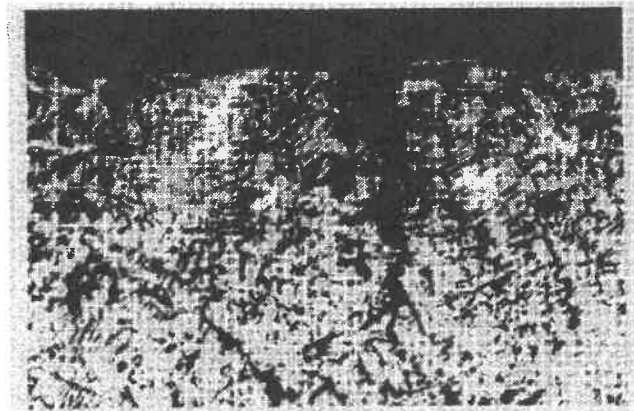
Figure 50. Microsection Showing Corrosion of Cast Copper Lead Structure.

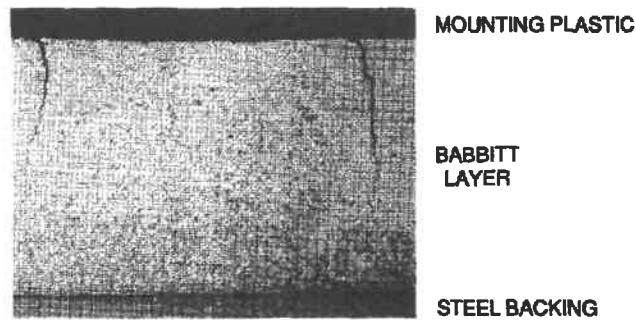
Figure 51. Cracks in the Babbitt Layer of a Sleeve Bearing.

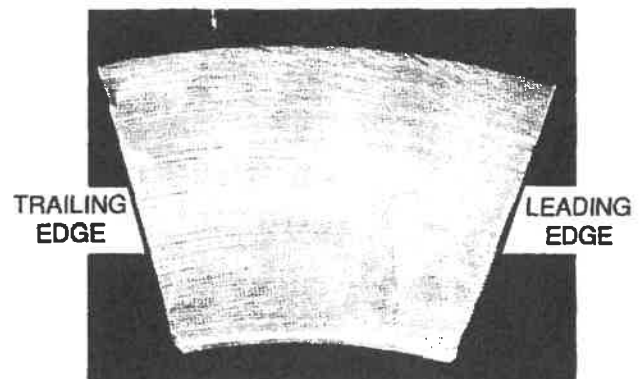
*Figure 53. Erosion Corrosion on a Journal Pad.*

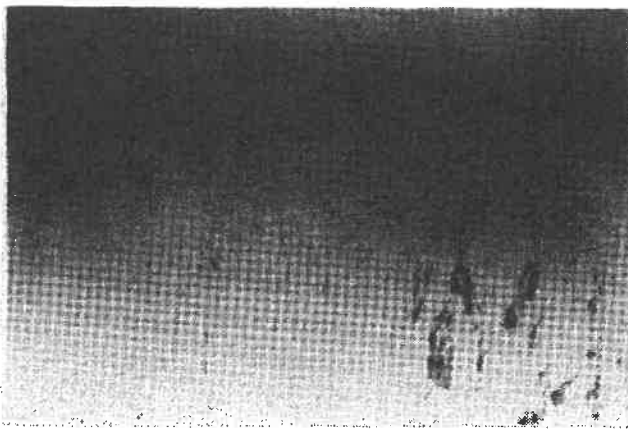
Figure 55. Cavitation Damage on a Babbitted Bearing.

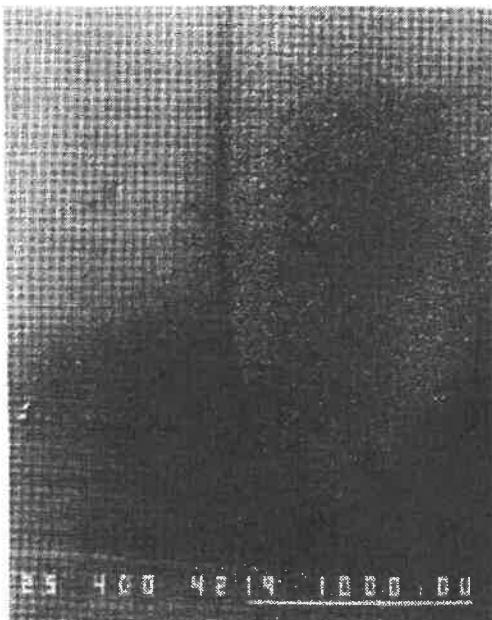
*Figure 57. Electromagnetic Shaft Currents Damage Magnified (3).*

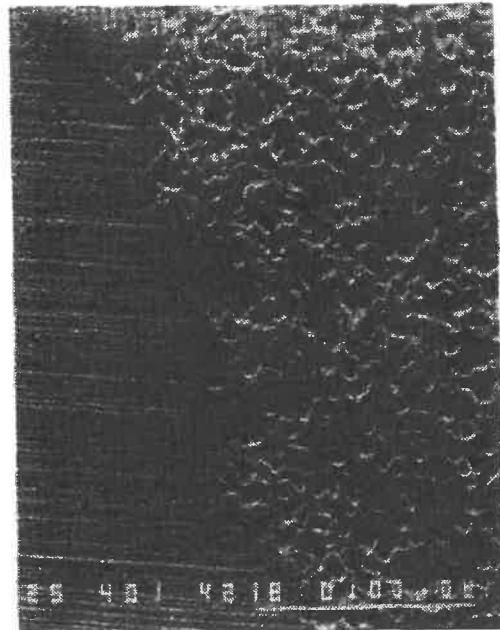
Figure 58. Magnification (40) of the Damage in Figure 57.

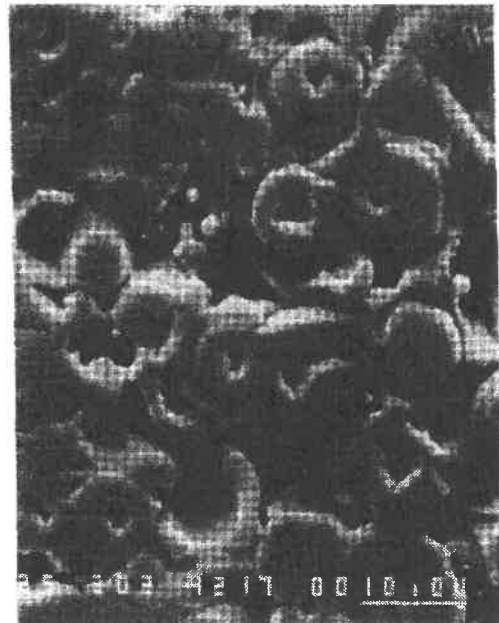
Figure 60. Magnification of the Rectangular Section in Figure 59 (2000).

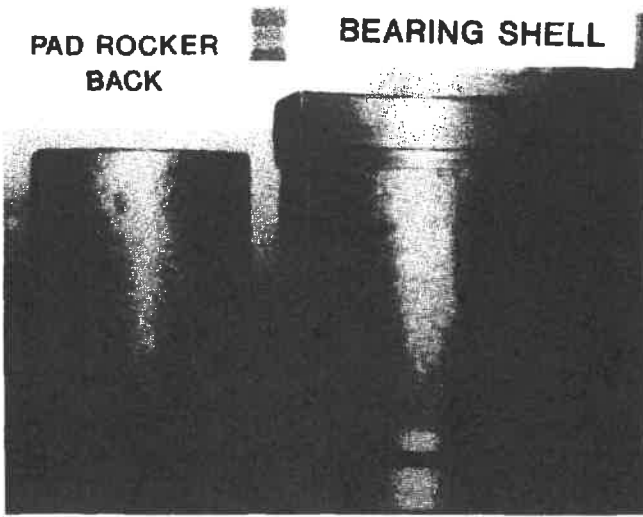
Figure 61. Brinelling on the Pad Back and the I.D. of the Bearing Retainer.
